Toast-R-Oven™ Toaster

Model TRO200

ACCIDENT INVESTIGATION REQUEST FORM

Document Number C335058

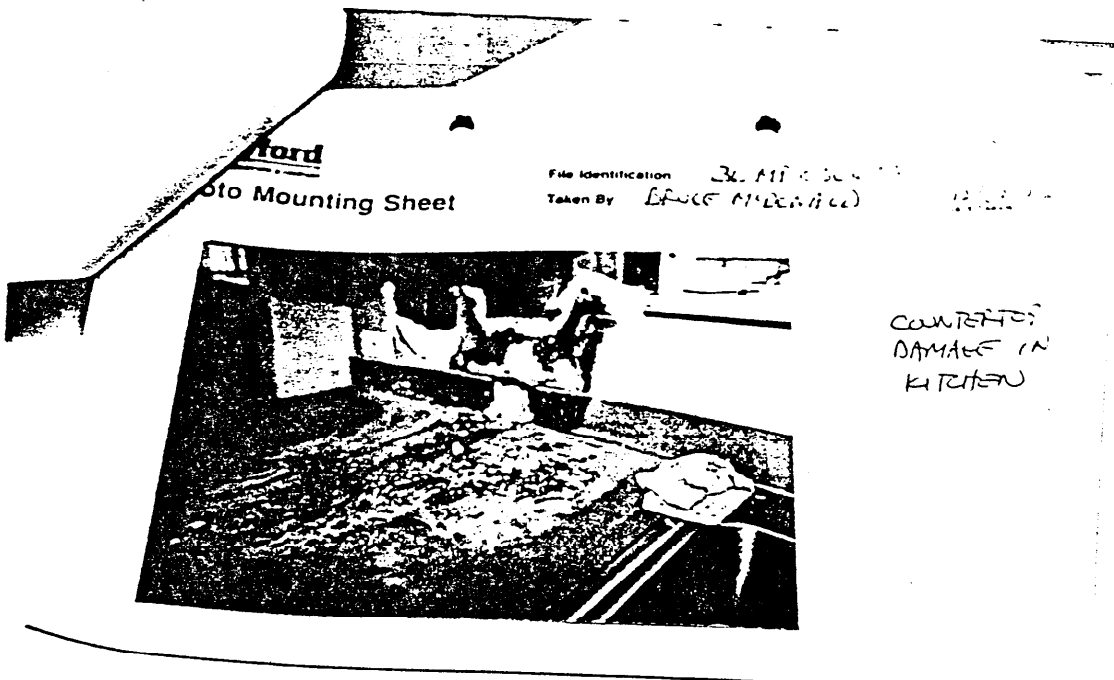
Photo # 2: Insurance photo of the kitchen fire damage.

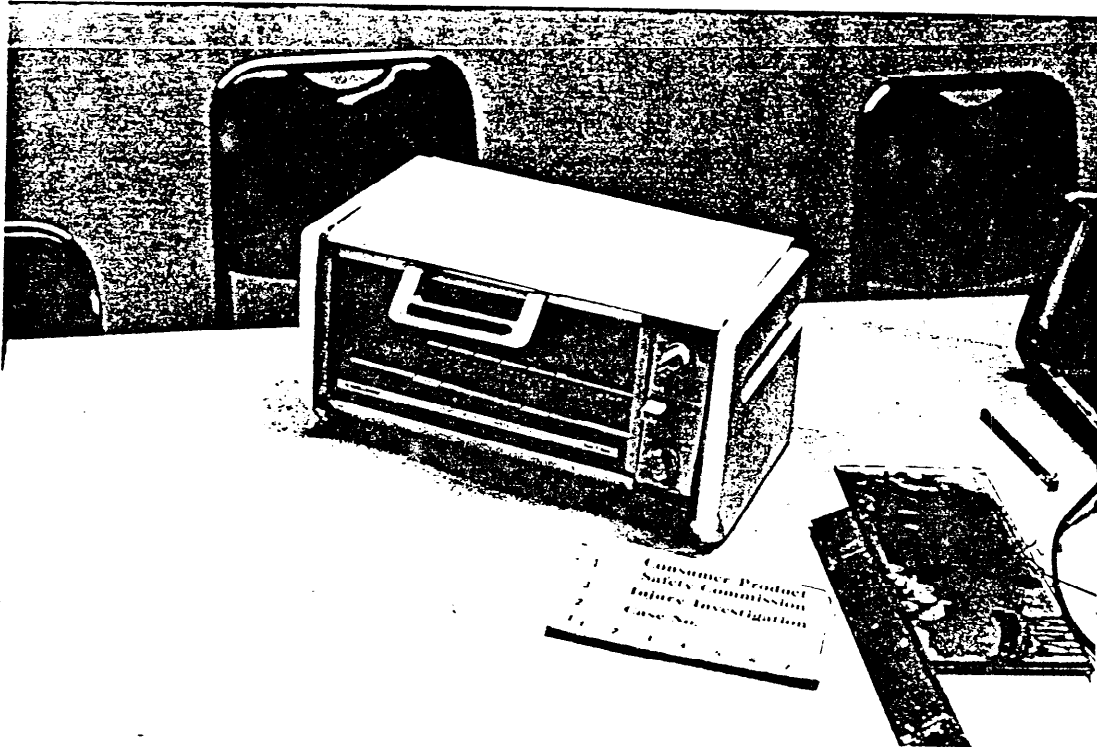
Photo # 3: Insurance photo of the area of origin of the fire.

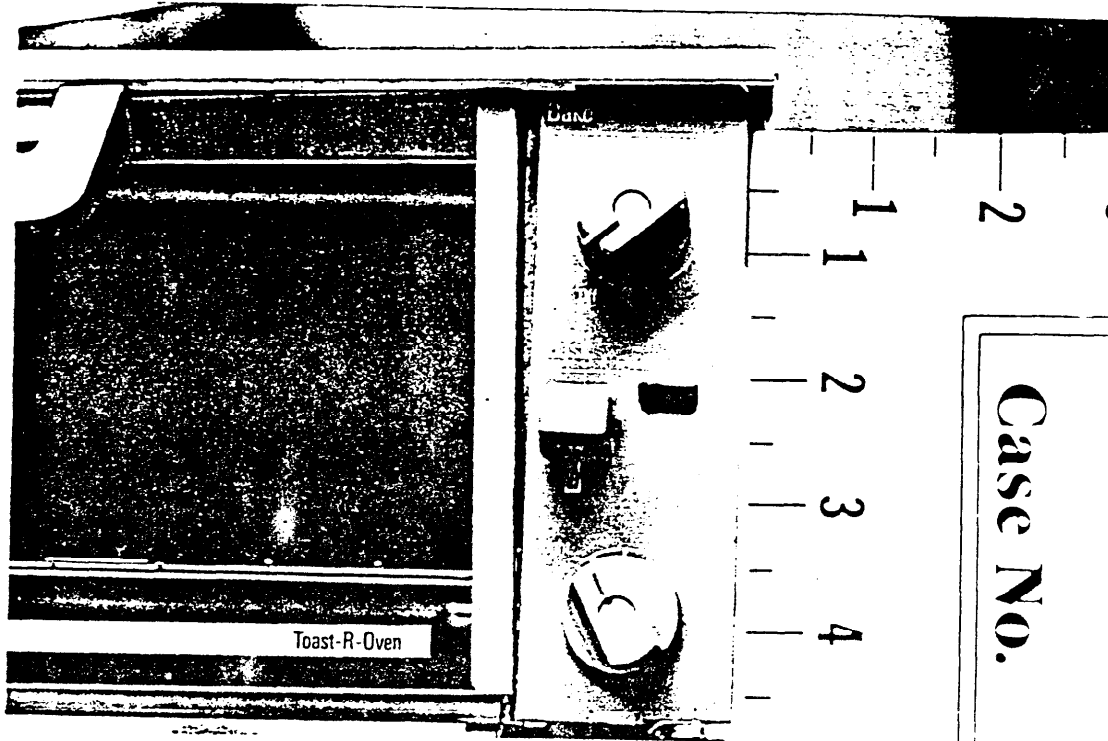
Photo # 5: View of the end of the fire damaged unit.

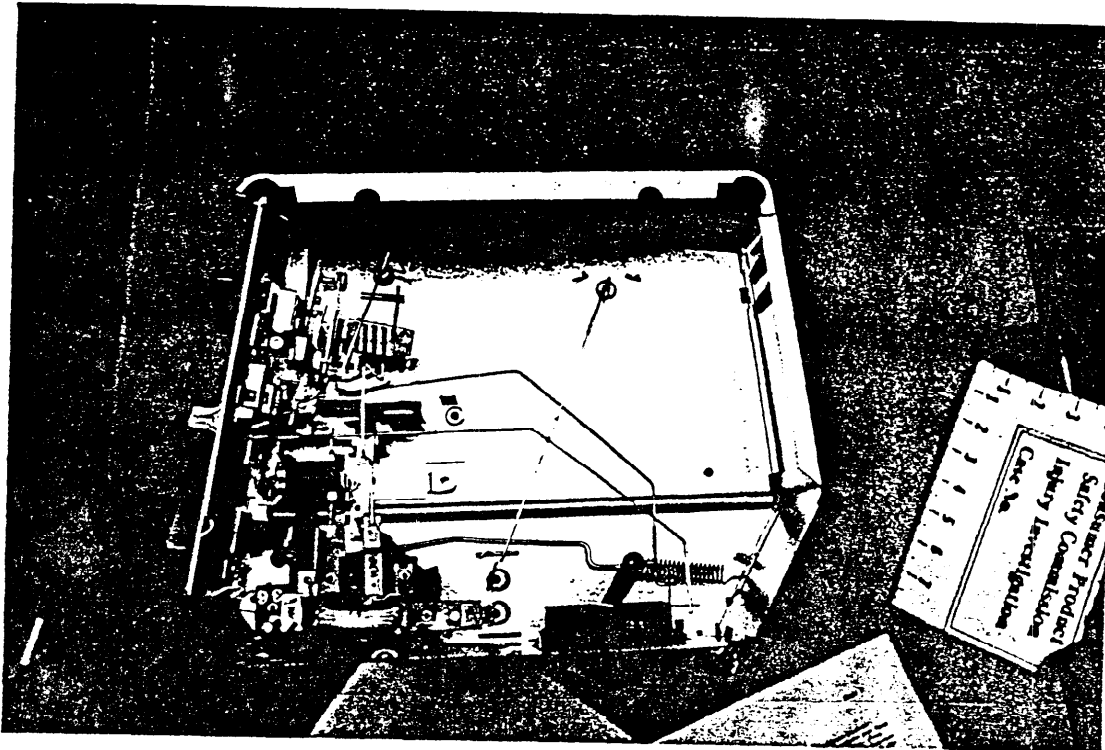
Photo # 7: (Side)
Fire damaged control panel.

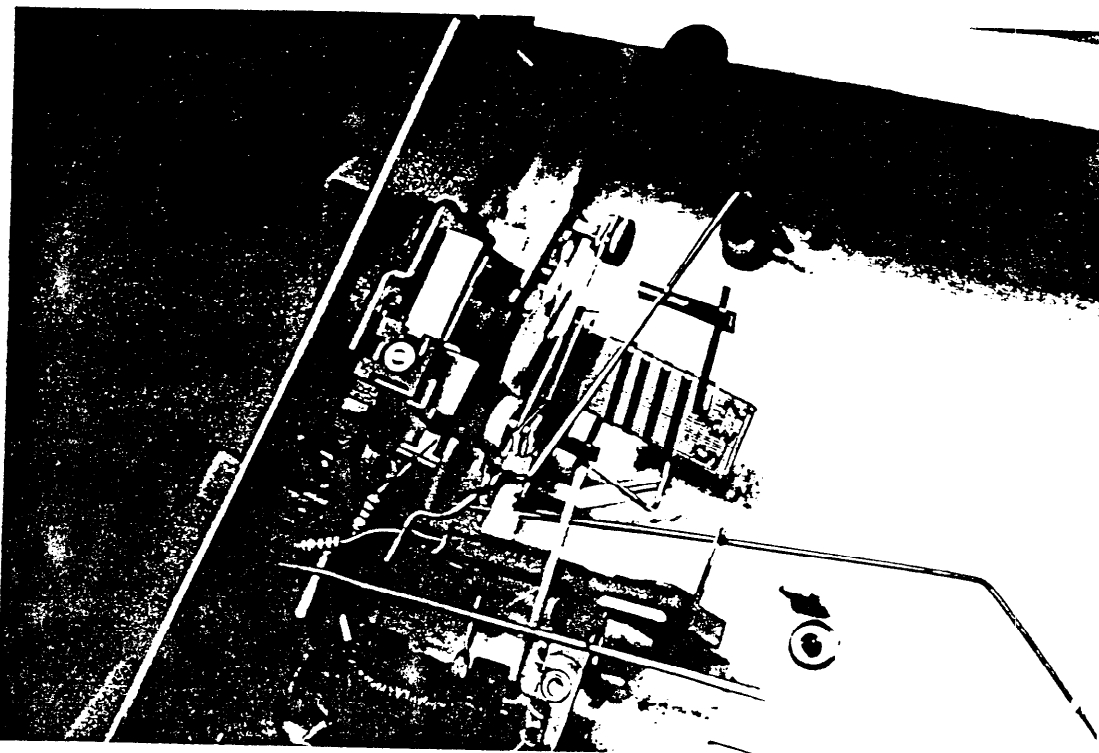
Photo # 9: Internal view, fire damage control compartment.

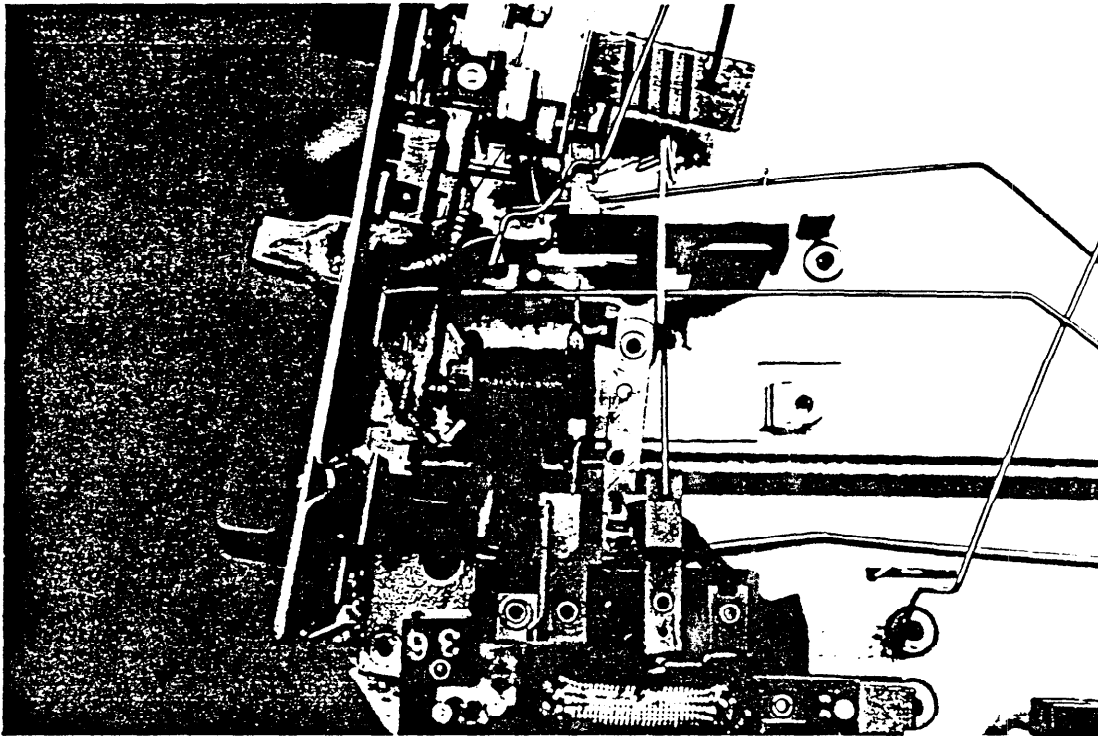
Photo # 11: Fire damaged unit thermostat.

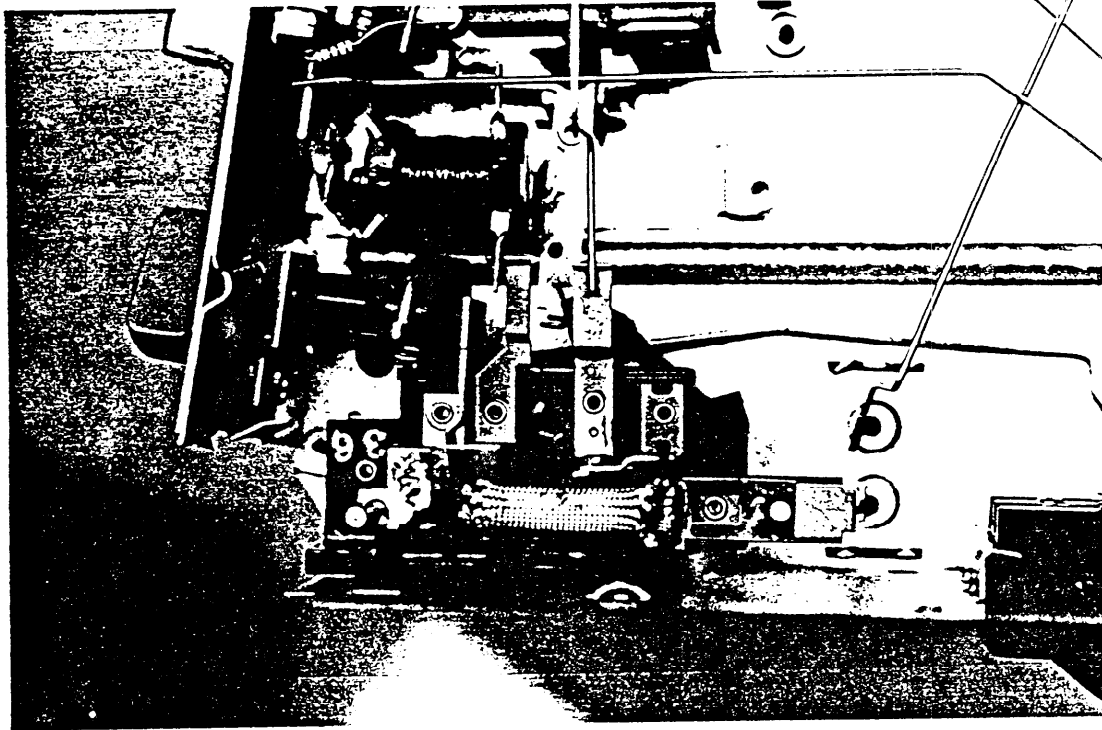
Photo # 13: Fire damaged unit controls with the remains of the solenoid removed.

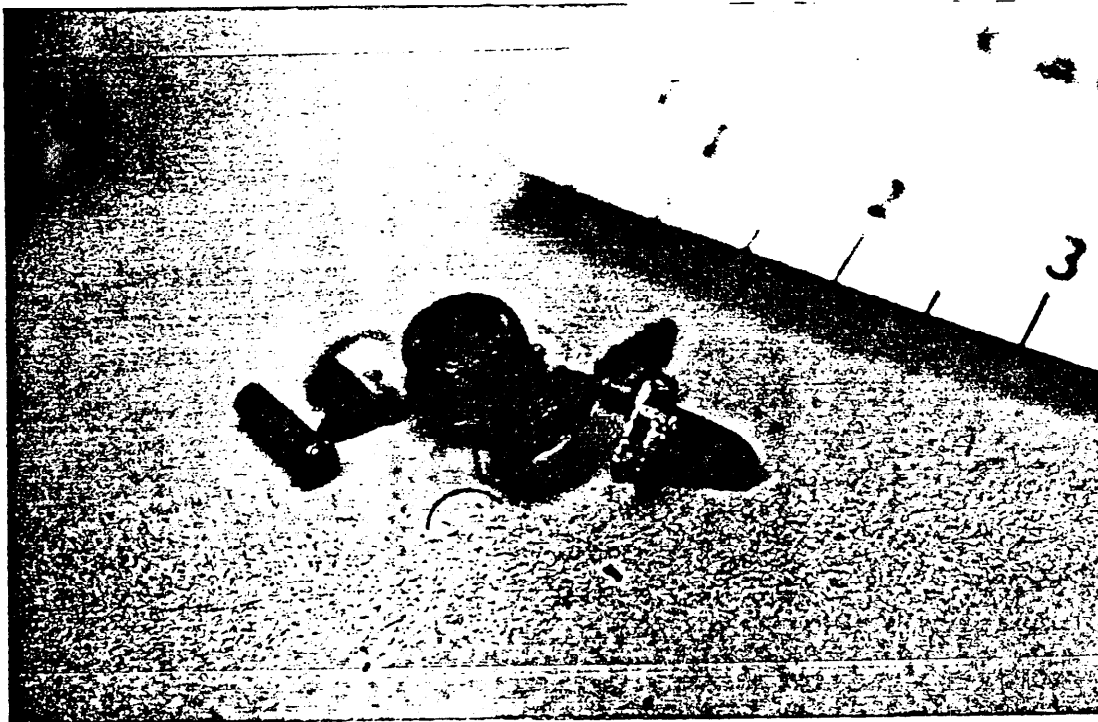
Photo # 14: Exemplar solenoid in the control circuit. The windings show heat discoloration which resulted from experiments performed by the forensic engineer attempting to recreate the fire cause.

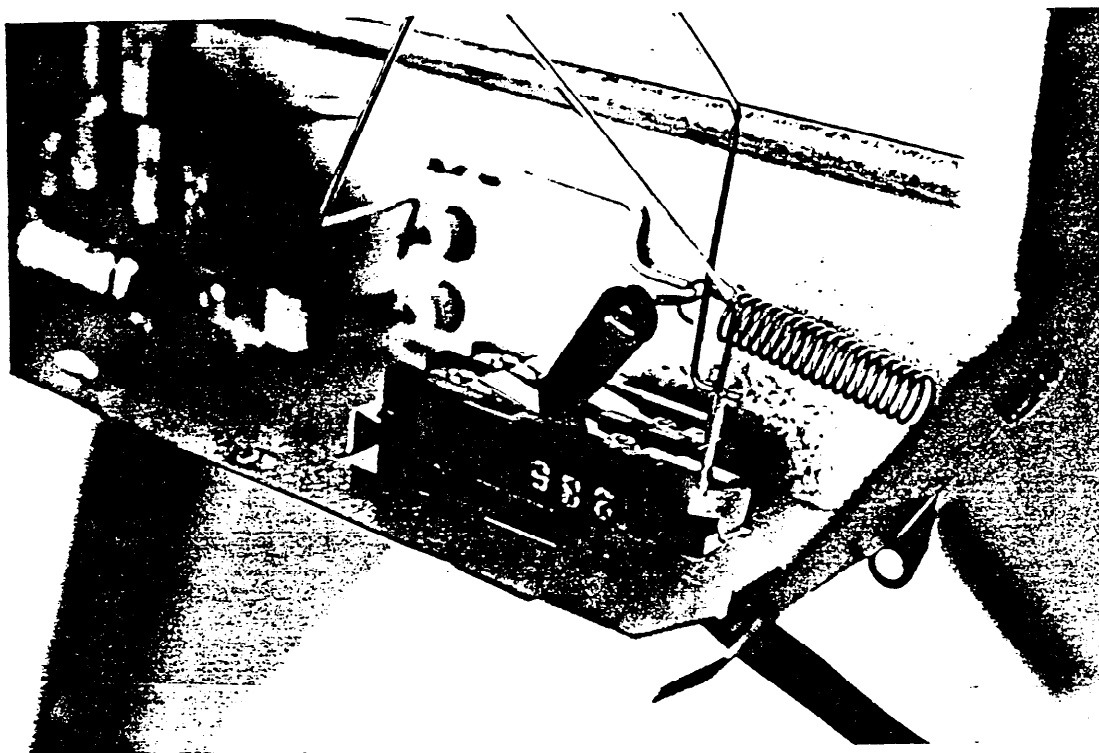
SCENARIO (1 sentence) Malfunction of an internal control on
B&D Toast-R-Oven caused uncontrolled
internal heating resulting in fire.

Photo # 15: Remains of the fire damaged unit solenoid which was removed from the unit by the forensic engineer.

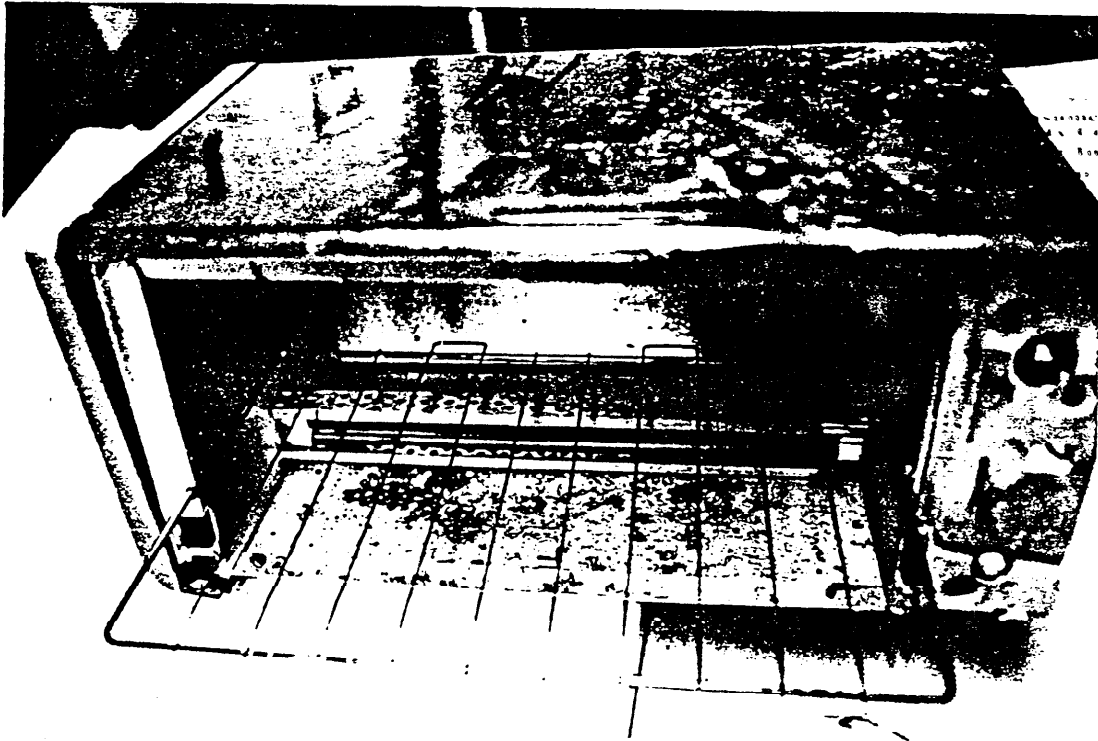
Photo # 17: Fire damaged unit door disconnect switch.

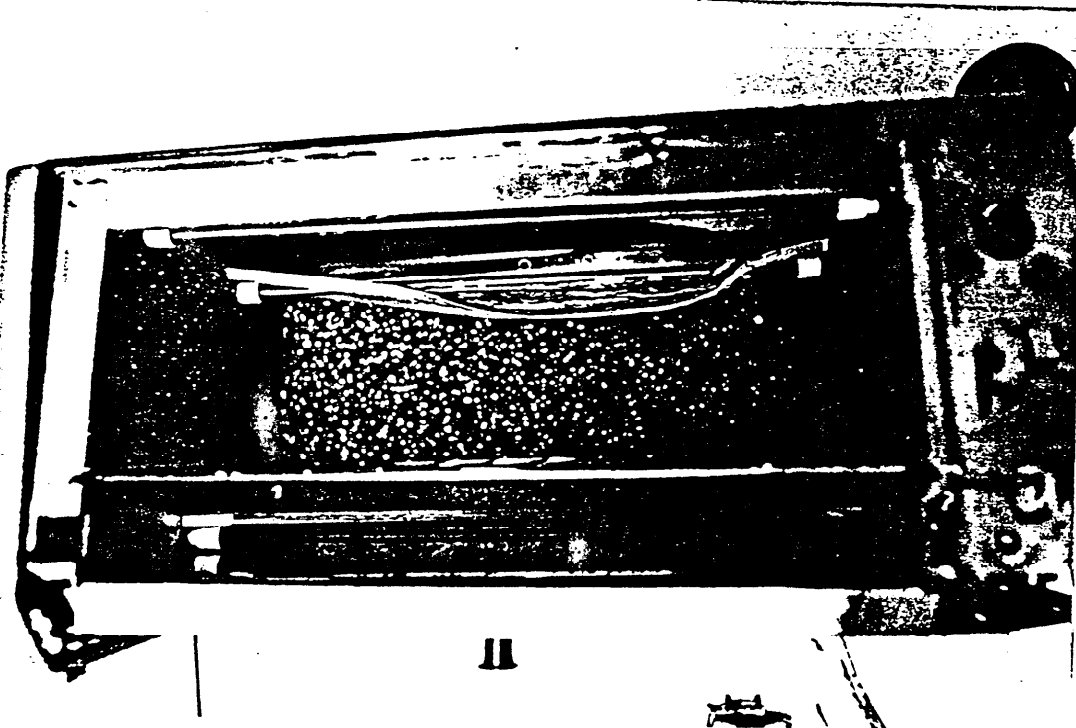
Photo # 18: View of the interior of the fire damaged unit.
